INDIANA HISTORICAL SOCIETY COLLECTIONS ADVISOR

Issue 109 | November 2020

COLLECTIONS STORAGE ASBESTOS ABATEMENT

By Sarah Newkirk, assistant director, Grover Museum

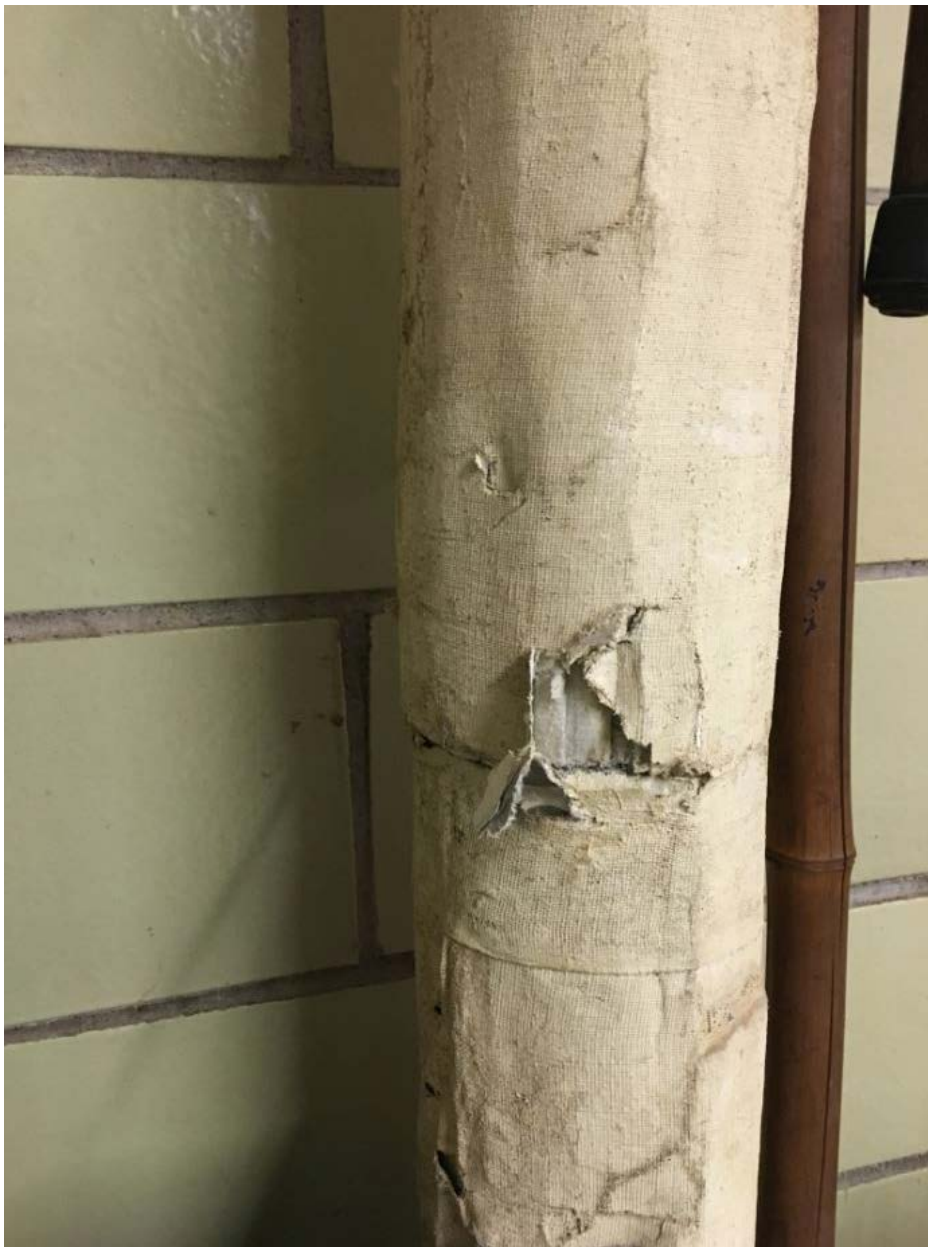
Crumbling asbestos wrapping found on a pipe at the museum.

Built in 1951, our building had several rooms in the lower level of our facility with exposed piping wrapped in a paper-like substance. These spaces were originally used for storage and utility rooms when the building was owned by the Elks. When the historical society opened the museum, these areas morphed into storage rooms for our collections. More recently, we noticed the wrappings around the pipes were damaged and beginning to crumble. We consulted with a local contractor who advised that the substance we were seeing was likely asbestos.

While this was an obvious and immediate concern, we knew further evaluation was needed. Until that could be done, we prohibited volunteers from accessing the storage areas and limited the staff's access as much as possible. Additionally, barriers were placed to prevent people and objects from coming in contact with the pipes. After consulting with professionals, we learned that our health and the health of others was not at risk as long as the material wasn't disturbed.

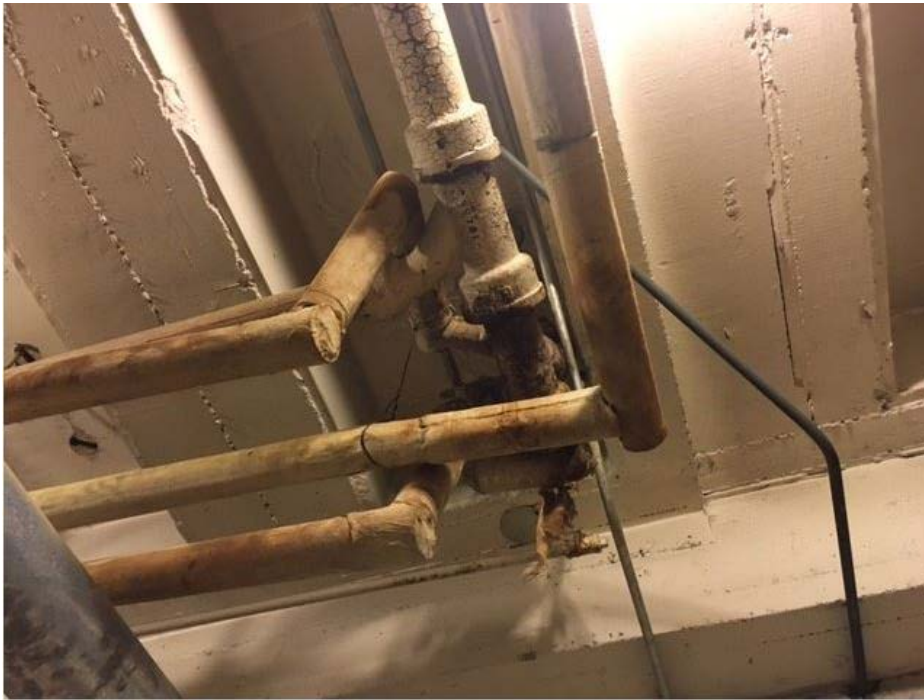
Pictured here are some of the pipes above one of our storage rooms. A piece of insulation had detached from the wrapping and was hanging above a storage shelf.

Following this, we sought the advice of an asbestos abatement company which had been recommended by the contractor. We were informed that we were, in fact, dealing with asbestos and it was recommended we complete a full inspection of the building to determine if the substance was utilized elsewhere. We sought suggestions from local contractors and obtained quotes for an environmental inspection of the building and asbestos removal (abatement).

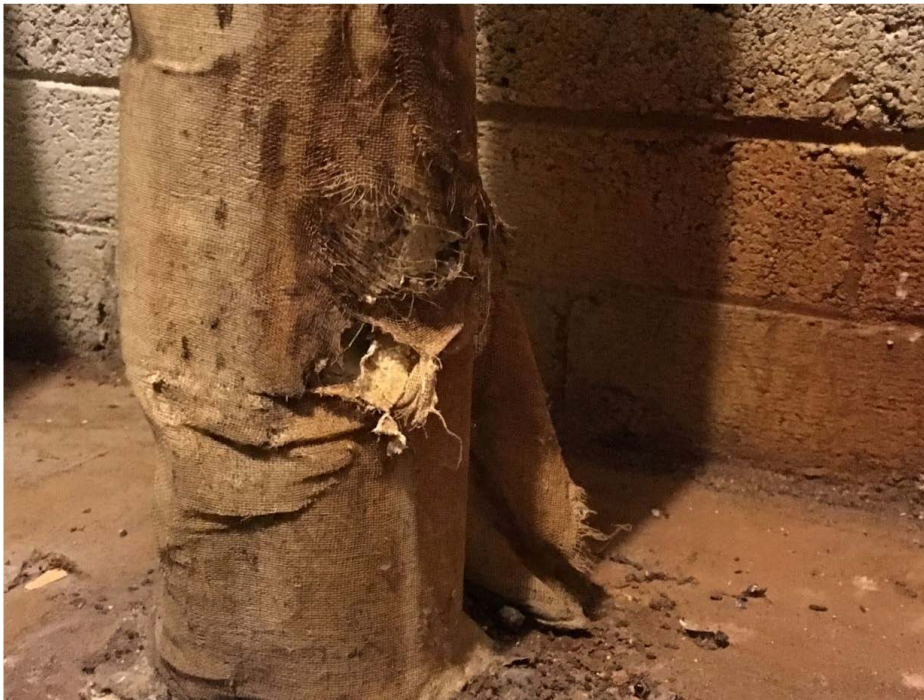
Close up of the asbestos fibers used in this particular type of wrapped insulation. We were particularly concerned with anyone coming into contact with this pipe due to the state of deterioration. We barricaded the pipe and only staff entered the room if absolutely necessary.

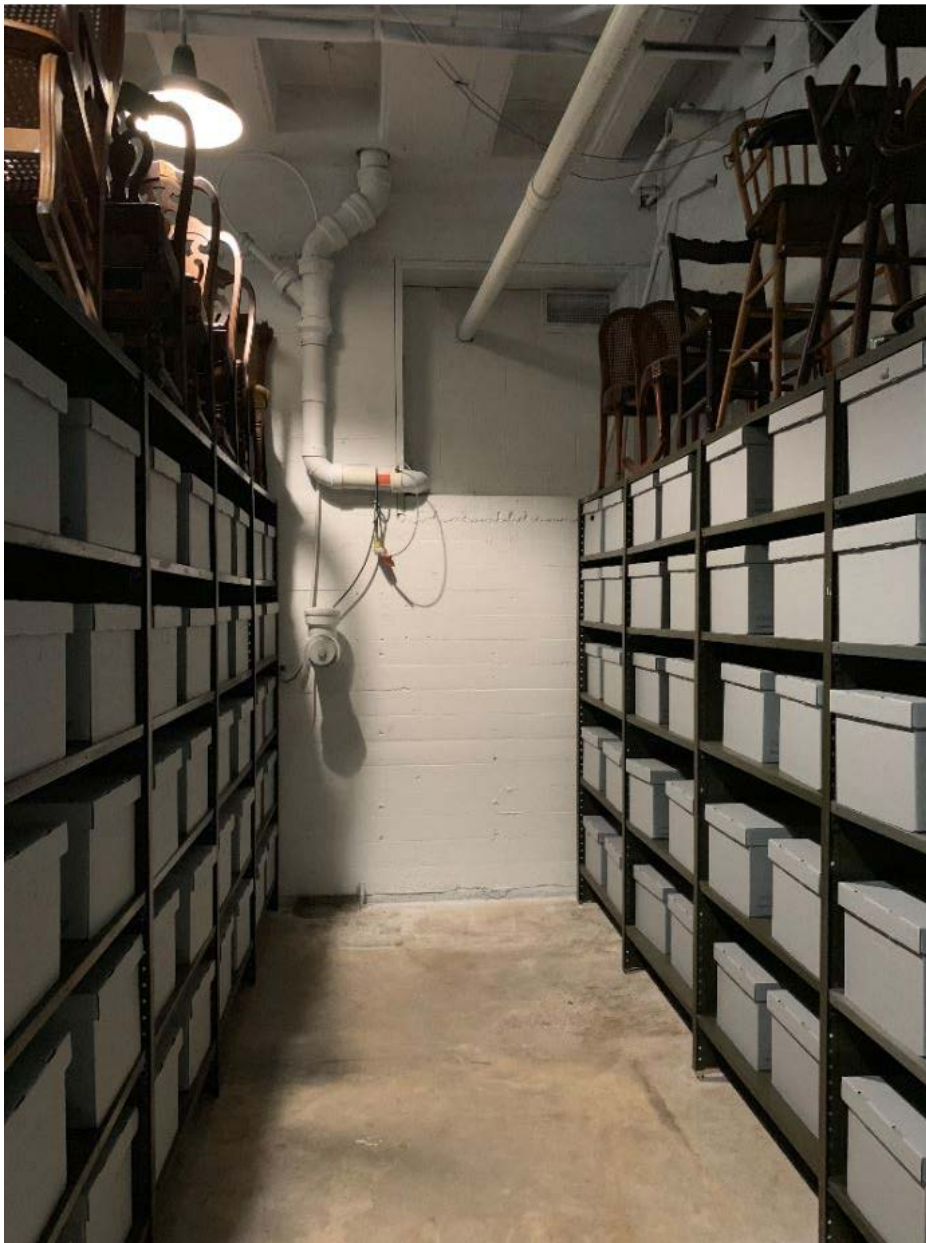
After the abatement and full collection storage remodel.

Once the artifacts were safely removed, the abatement company was able to begin their part of the project. They began by sealing a portion of our lower level with plastic and covering all vents so particles could not escape to other areas of the building. At this point, this area of our building was off-limits to anyone but the crew. Over the course of two days, the asbestos insulation was removed from our pipes. Clad in full hazmat suits, the crew wet small sections of the asbestos wrapped pipes and then cut the wet section away from the pipe. This mitigated the possibility of particles becoming airborne. Each section was placed in contamination bags and sealed. Each bag then went through a decontamination process before being removed from the building. Once the asbestos materials were removed, the crew cleaned the space with HEPA filtered vacuums and removed all plastic coverings before vacuuming again and turning the space over to us.

As rooms were repaired, cleaned, and painted over the following months, artifacts were housed in new storage containers thanks to an IHS Heritage Support Grants Mini Grant and stored on new metal shelves. A volunteer campaign was launched to build a base of volunteers to clean artifacts, complete condition reports, and properly store artifacts.
